200 Market Street, Portland December Data Acquisition Report

Site Description:

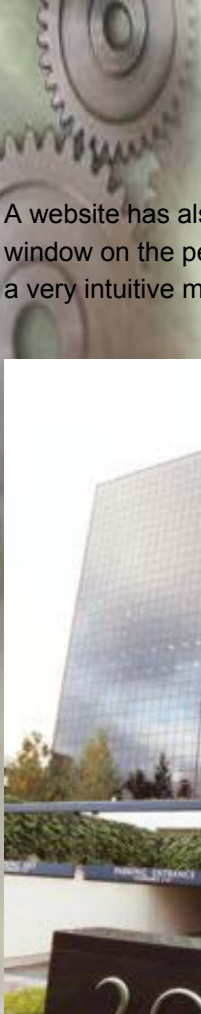
Figure one present the front of the office building with the new Cooling, Heating and Power (CHP) demonstration building located on the ground floor on the left side facing the front of the building. This new building addition blends into the "green" nature of the building with a three foot deep earth roof. The prominent picture window was constructed to allow the public to view the CHP systems as well as the computer monitoring system.

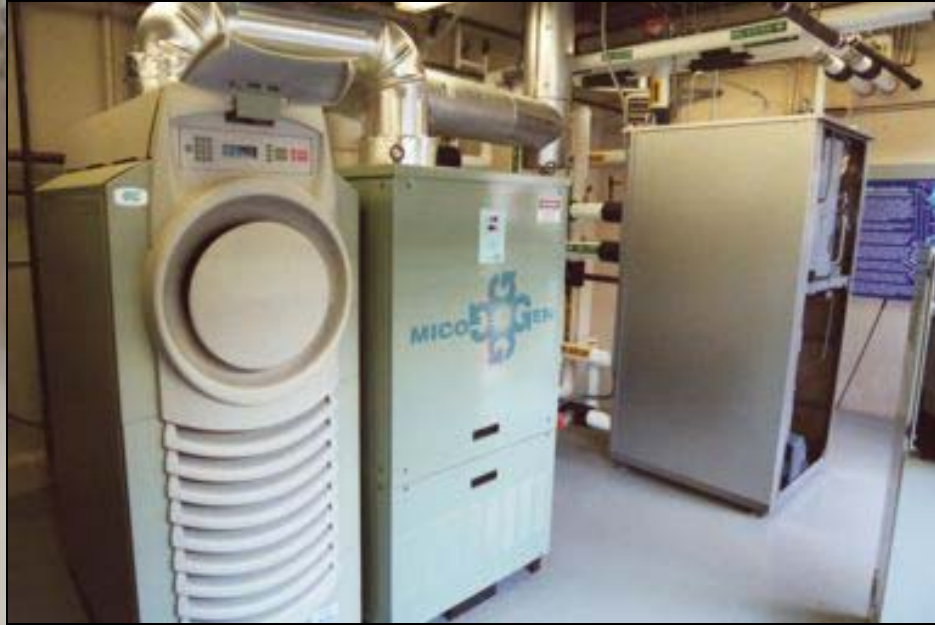
Figure 2 Microturbine, Heat Recovery Heat Exchanger and Absorption Chiller

Figure two presents the nominal 30 kW Capstone microturbine (left), a Unifin heat recovery heat exchanger (center) and finally a Yazaki nominal 10 refrigeration ton (RT) (right). The insulated exhaust duct work delivers the microturbine exhaust to the Unifin heat exchanger (top left foreground) and the flue gas exhaust leaving the Unifin (background right). Figure three presents the opposite view of the CHP facility where the back of the control station is seen on the left.

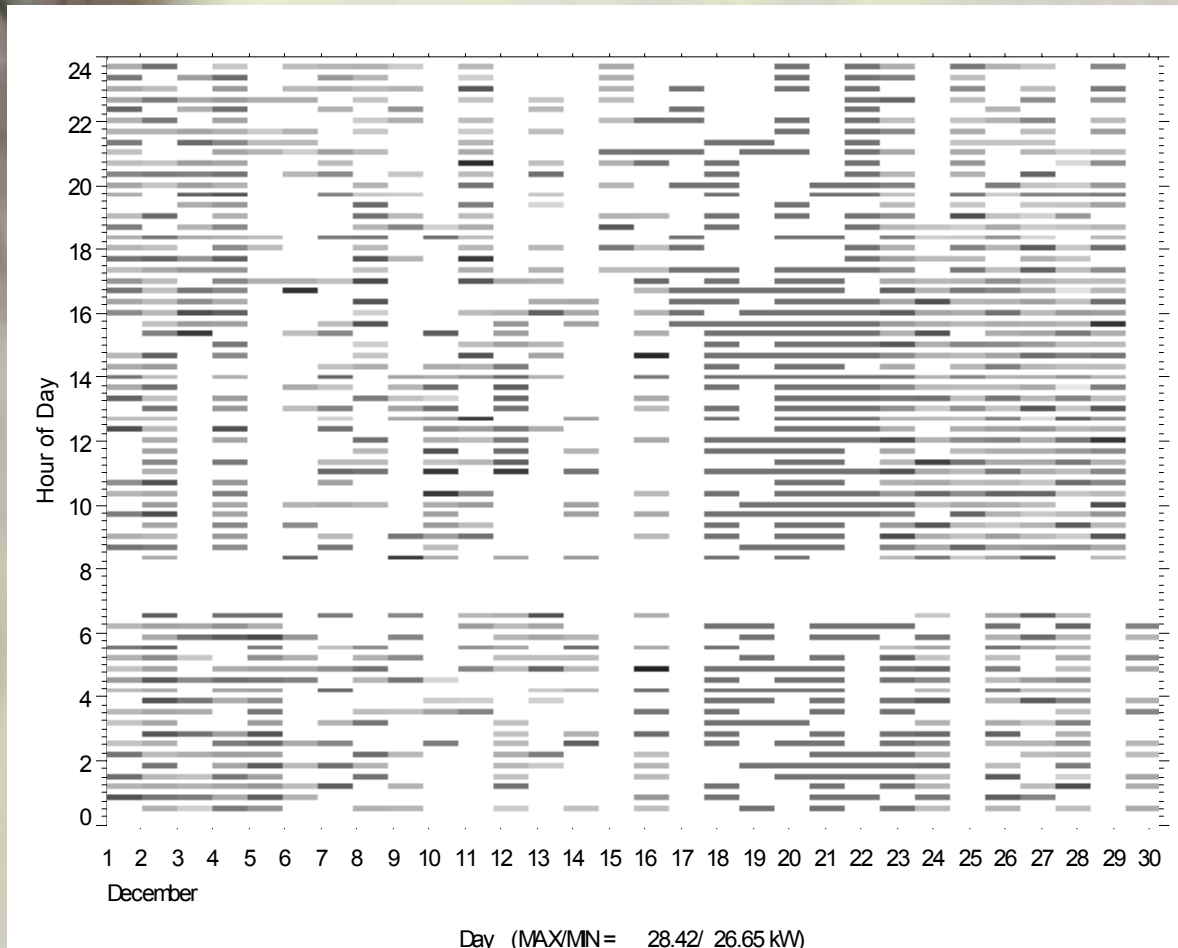
Figure 3. Shade Plot of Turbine Power Output

The shade plot in Figure 3 shows when the data are missing (white areas) as well as when the turbine ran (darker areas). None of the data collected ever indicated that the turbine was off in December.

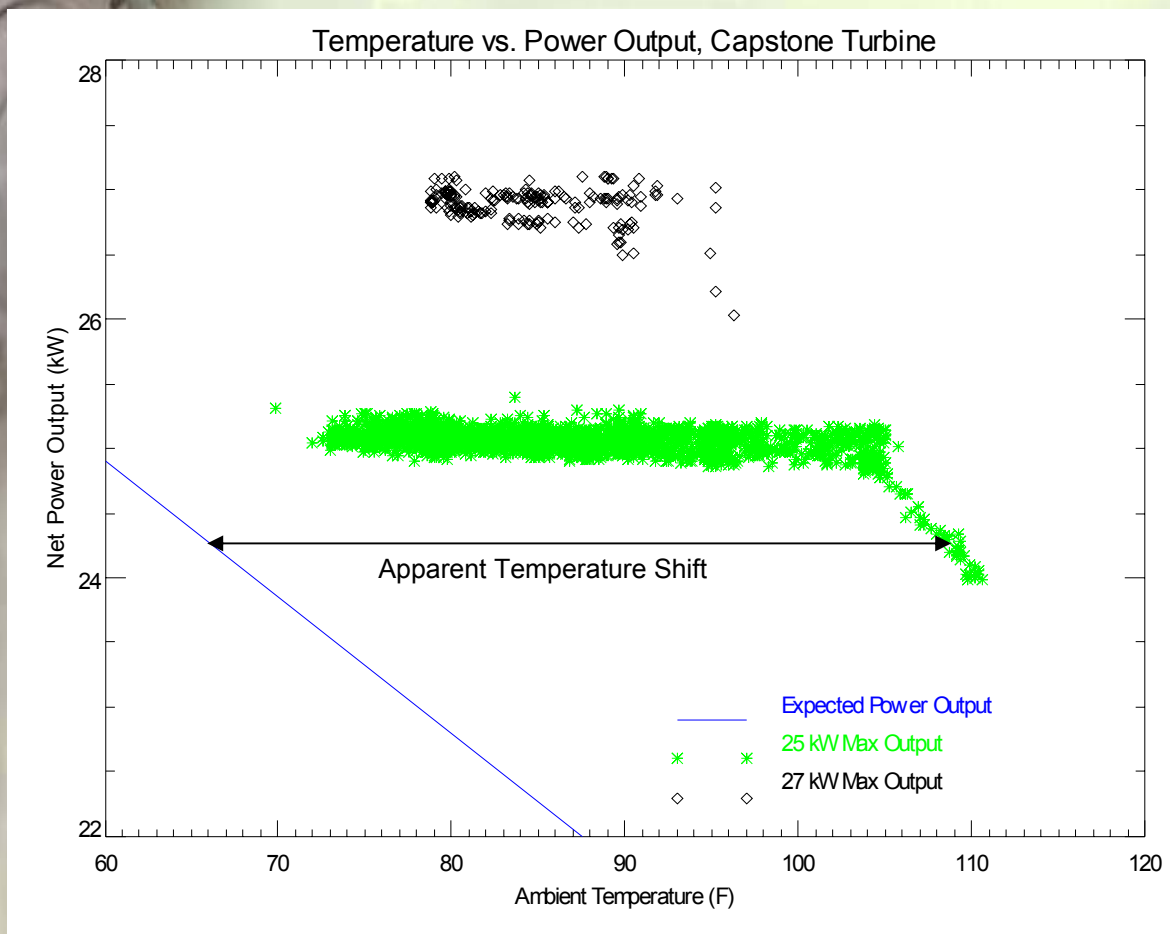
Figure 4. Trend of Measured and Expected Net Power Output with Ambient (all data)

The following plots (Figure 4 through 6) compare the measured performance of the Capstone 30 to the expected trend. The data shown as *black diamonds* are for the periods before August 2, 2002, when the turbine had been set to produce its rated output of 27 kW. After August 2, the turbine output setting dropped to 25 kW. These data are shown as *green **s. The blue lines on the graphs are the expected performance trends with ambient temperature from the published Capstone specifications (converted to higher heating values).

Both the power and efficiency are higher than expected at the high "inlet" temperatures recorded in the mechanical room by the Capstone SCADA system. Though the results may imply that the temperature sensor is somehow skewed. If the data in all three plots were shifted to the left by 40-45°F, the measured data would be more in line with expectations.

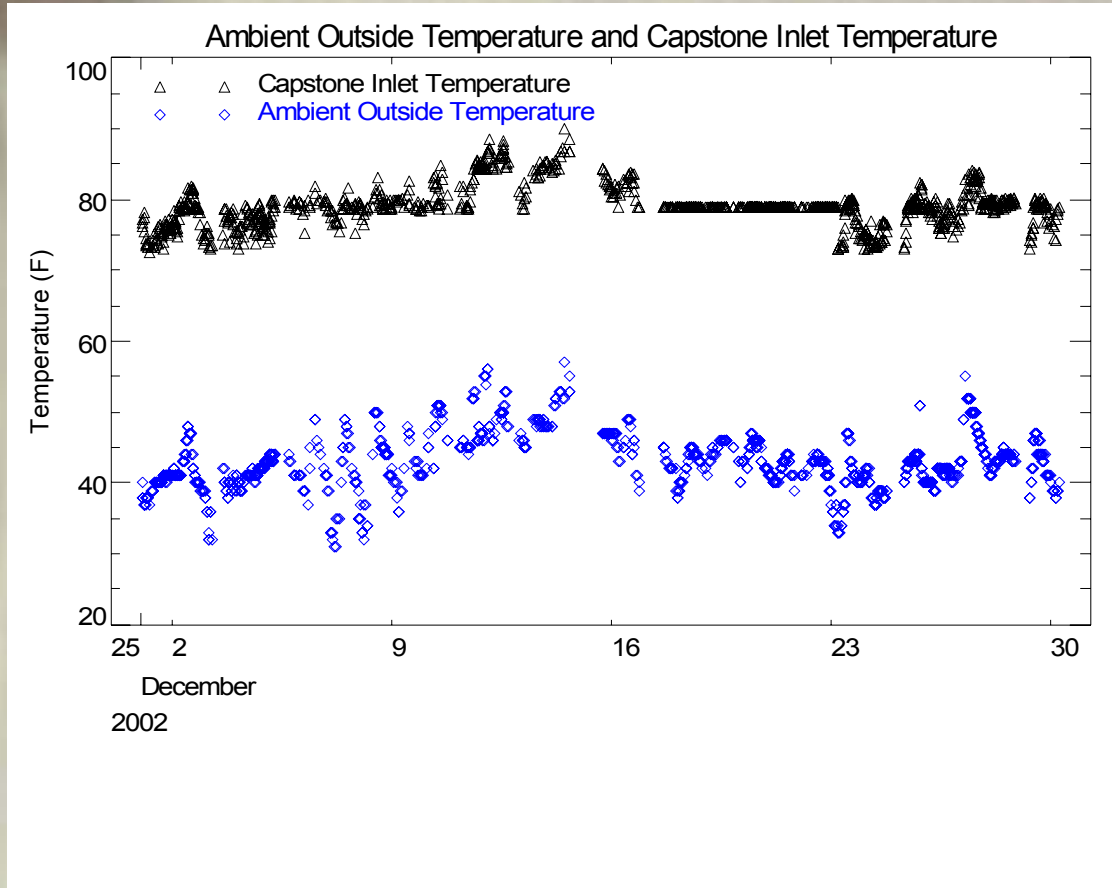
Figure 7. Comparing the Capstone Inlet Temperature to Local NCDC Readings (Portland Airport)

Figures 7 and 8 below compare Capstone inlet temperature to the hourly weather data for the Portland Airport (Station 24229, obtained from the National Climatic Data Center (NCDC) weather database at www.ncdc.noaa.gov). Figure 7 compares the outside air temperature to the turbine inlet temperature when the turbine was running. Figure 8 compares the two values for a one-week period in December. The turbine inlet is consistently 35-40°F warmer than ambient. For a 6 day period in December (see Figure 7), the inlet temperature sensor was a locked at a constant value and appears to have malfunctioned. While it is possible that the mechanical room is slightly warmer than ambient, the turbine performance trends above imply that the room is probably not as warm as the sensor reading (since this puts the turbine performance well above expectations).

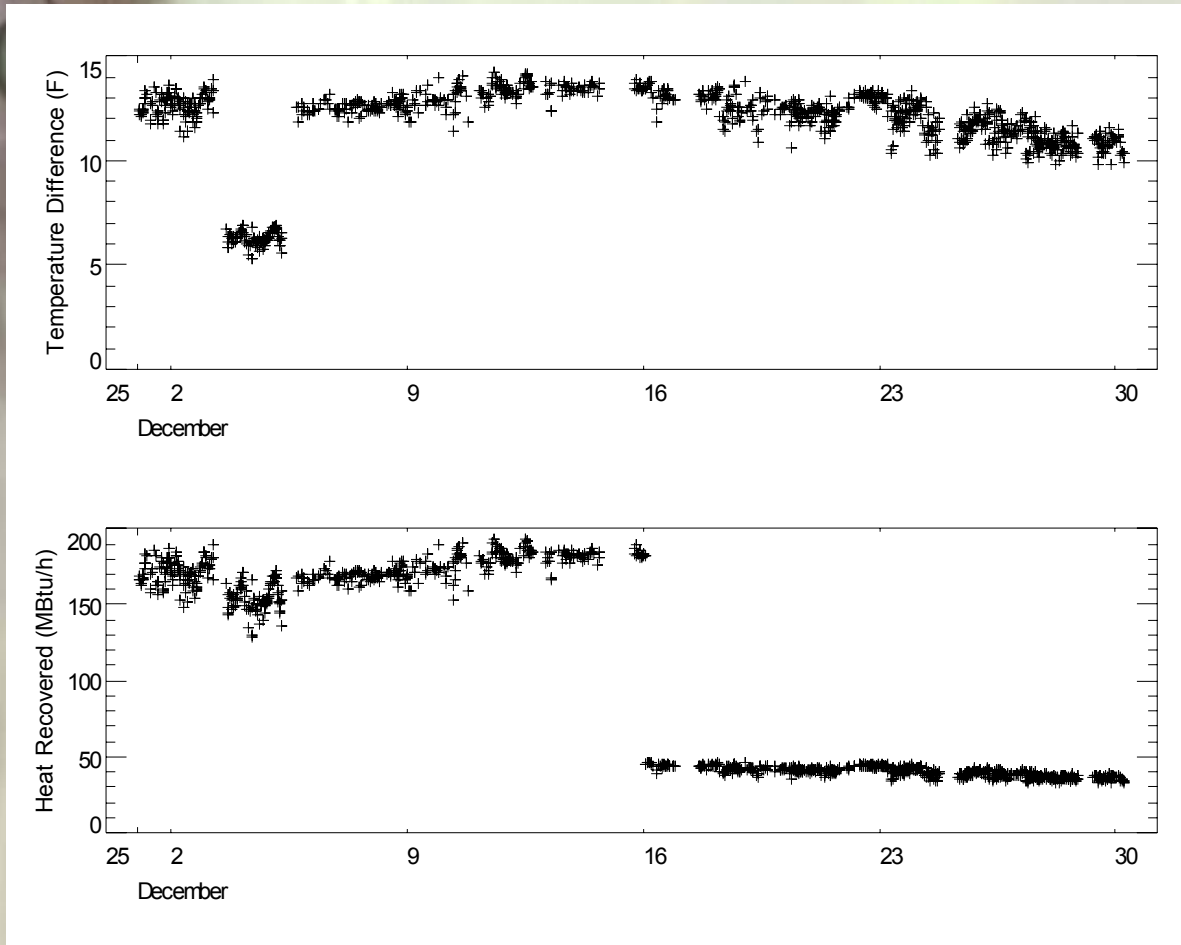
Figure 9. Unifin Delta-Temperature and Heat Recovery Rate

The Unifin heat exchanger (HX) transfers heat from the turbine exhaust to the hot water loop. Figure 9 shows that the hot water temperature rise across the HX was typically 10 to 15°F, providing between 150 to 200 MBtu/h of heat recovery. Figure 10 shows the temperatures and flow rates in the HX unit. The exhaust temperature is around 400°F and leaving exhaust temperatures from the HX unit are just above 200°F. The hot water flow rate was around 27 to 28 gpm for the beginning of the month. Figure 11 shows the heat rate against the expected trend. The measured values are lower than expected. These trends were consistent with the previous months of operation.

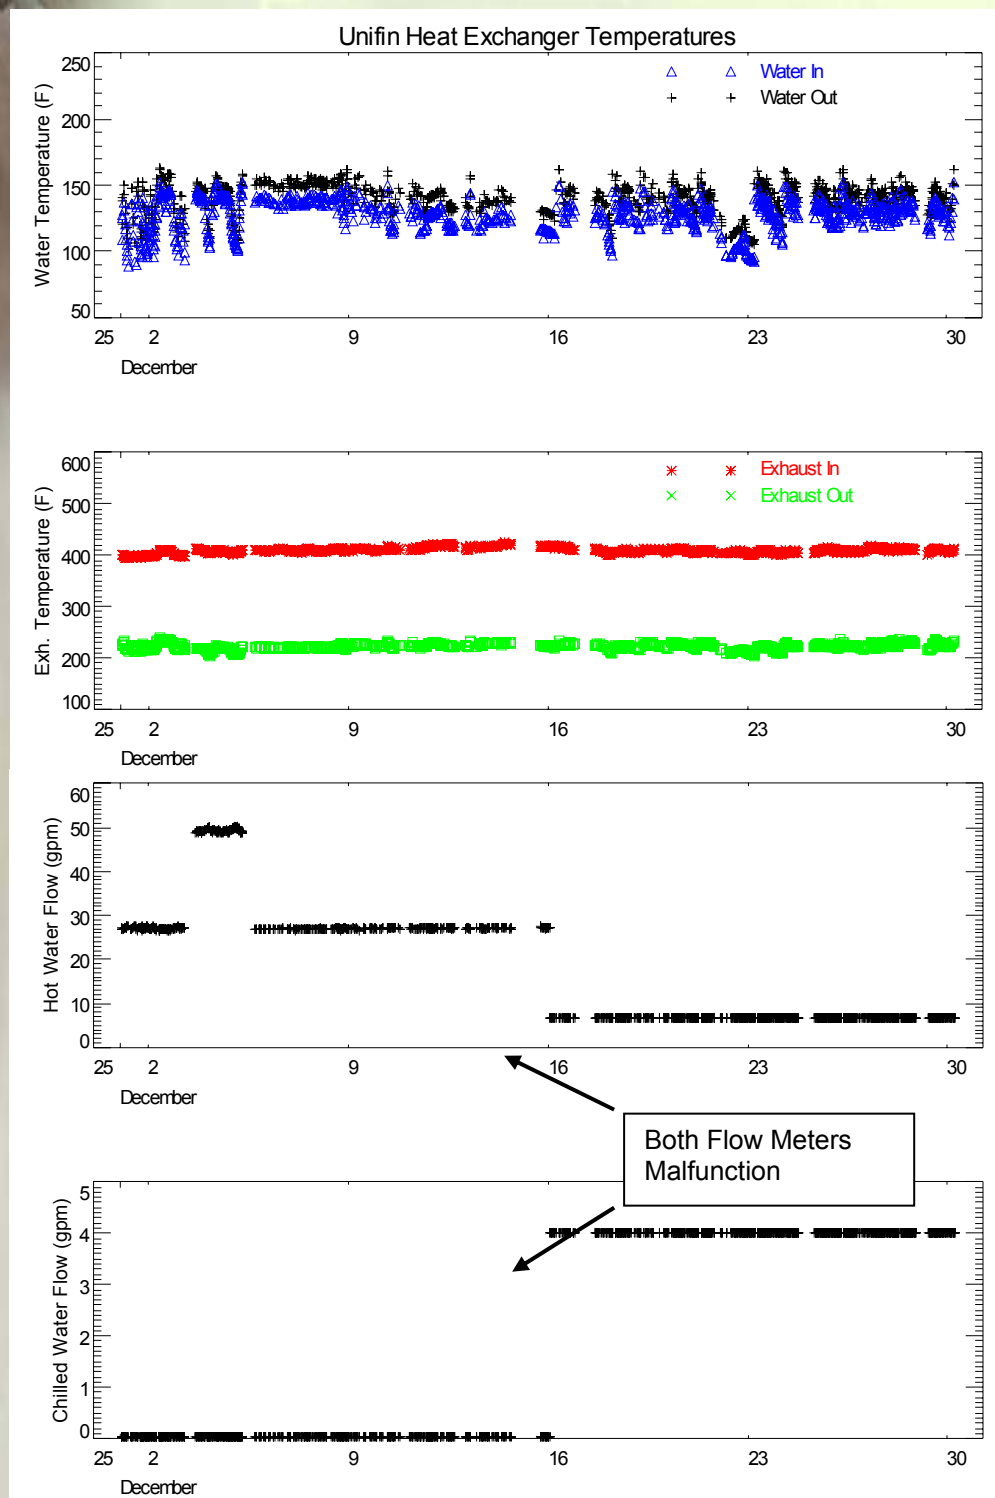
Figure 10. Unifin Exhaust and Water Temperatures Along with Hot Water Flow Rate

After December 16th, the hot water flow meter appears to malfunction. The hot flow rate drops to 7 gpm (as shown in Figure 10) yet the hot water temperature rise remained unchanged (Figure 10). This implies that the change in flowrate did not really happen but was an instrumentation issue. At approximately the same time, the chilled water flow rate jumped to 4 gpm (Figure 10). However, the chilled water temperatures also did not indicate any change in flow through the chiller at that time (i.e.,

these temperatures continued to float between 60-70°F, the average conditions in the mechanical room). Therefore, it appears that both the recorded flow readings are erroneous.

For about 1½ days starting December 3, the heat recovery flow rate suddenly jumped to 50 gpm and the hot water temperature rise correspondingly dropped to 6°F. The overall heat recovery rate remained about the same (as would be expected with the high entering exhaust temperatures on the other side of this heat exchanger).
